Karst-Collapse Activity in Cam Lo District, Quang Tri Province, Vietnam

**Tran Thanh Nhan, Dr.
Nguyen Van Canh, Prof.
Do Quang Thien, Dr.
Tran Huu Tuyen, Dr.**

**Department of Engineering Geology and Hydrogeology
Hue University, Vietnam.**

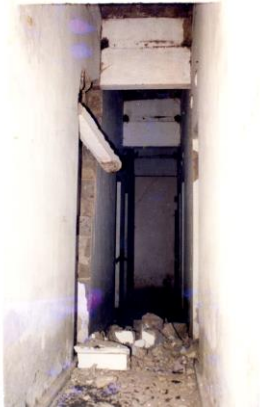
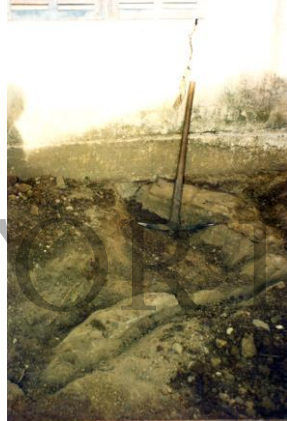
Cam Lo Hospital, Thiet Trang area (1993 -1993):

- Occurred in 1993 – 1994
- Sinkholes with dimensions of 4-5m in diameter and from 0.5m to 2-3m in depth under Cam Lo Hospital Center foundation and in agricultural land.

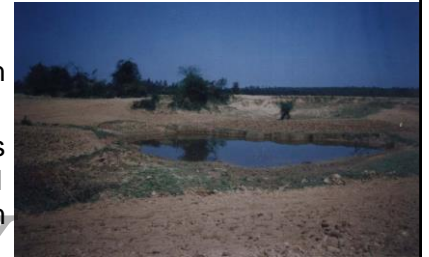
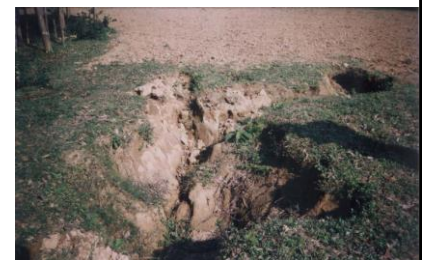
Hau Vien, Trung Vien and Thuong Vien (from 1990)

- Consecutively occurring with high intensity, especially in 1998.
- Total number of 112 sinkholes with various dimensions: from 0.1 to 8.0m in diameter and from 0.5m to 7m in depth.
- Damage local houses.

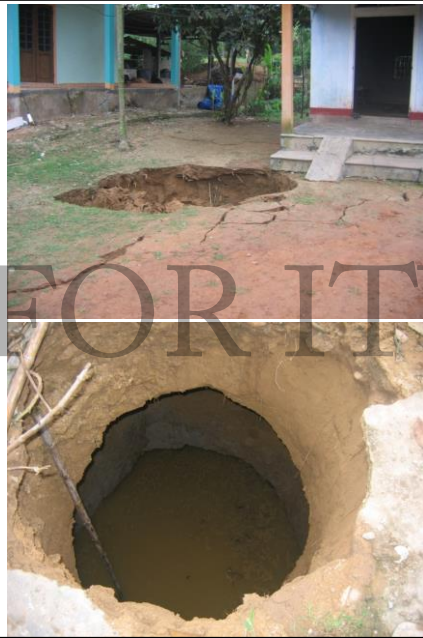
Tan Hiep area

- Occurred from February 18 to October 3, 2006 with total number of 52 sinkholes.
- Sinkholes distribute in EN-WS direction being coincident with tectonic fault F2.
- Sinkholes with dimensions of 0.2-5m in diameter and 4-5m in depth. The largest sinkhole has diameter of 25m.
- Damage and directly affect 122 out of 178 local houses and road.

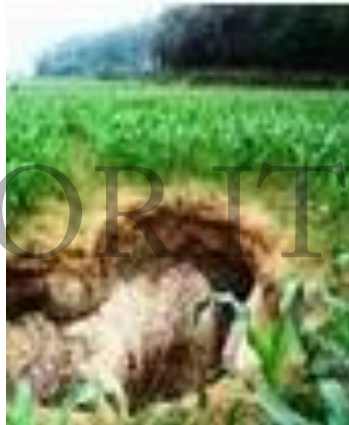
Tan Lap area

- Occurred in 1999 and 2006 related to heavy rain during historical floods in 1999 and 2006.
- Sinkholes with diameter of 1.5-4m and depth from 0.5 to >5m distributing along the bedrock of Co Bai formation.
- Mainly occurred on agricultural land area.

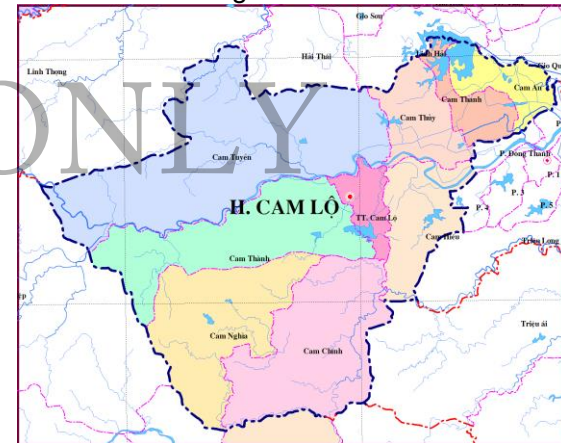
Regional meteorological - hydrological condition

- Long term of dry weather was immediately replaced by heavy rain, commonly in April, May, September and October.
- Strong relationship between Hieu river and underground water.
- Vertical variation of underground water level from 5 to 6m.
